<i>i</i> /, ,	CLASSIFICATION SECRE	25X1
COUNTRY	Soviet Zone of Cormany 25X1 REPORT NO.	
	Railroad Bridge over the Libe River in Ceissen	
TOPIC	William plings over one most track with cipacit	or publishments markishments, mekkenda // a antika-mark fem och (a as alah antikasa)
		THE PROPERTY AND A THE CONTINUES AS A THE SESSION WHICH SERVICE AND A THE SERVICE AND A THE SERVICE AND A SERVICE AS A THE SE
EVALUATION	PLACE OBTAINED_	25X1
DATE OF CONT	<u>25X1</u>	والمراوات
DATE OBTAINE	D 25X1 DATE PREPARED 7 Nugus	t 1950
REFERENCES_		
	2 ENCLOSURES (NO. & TYPE) 2-)	mayora a-
PAGES	URN TO CIA	
REMARKS		- 25 State - Court is indicated the company and a state of the court in the court is the court in the court i
dereka nijeka prikaje Majirani kili karamen kilada i Maje e Alijek i Alijek	25X1 LBRARY	
		EVALUATE
	77	Pro am to be a
	The bridge, 200 meters upstream Reissen highway bridge is on the Dresden (K 52.	/1° 29) -

Coswig (N 52/F 27) - Heissen - Doobeln (N 52/K 79) Grossbothen (N 52/K 59) - Leipzig (N 52/E 21) trunk line,
which is now single-track. See Annex 2 for photograph of
the bridge. The bridge is of considerable importance for
rail operation in the Saxon industrial area although t

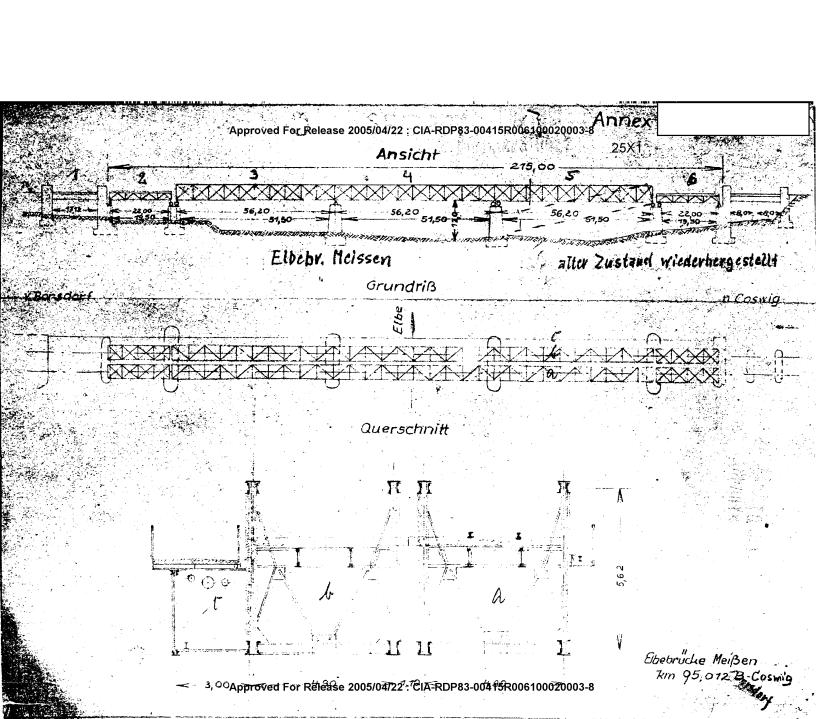
to be operated again as a double-track line, the remaining
work can be performed very quickly. The sidewalk of the
bridge, 3 meters wide, is usable. The water depth at the
bridge is 1½ meters at mean wa er, 10 meters at high water.
The river is normally 110 meters wide under bridge and the
river bottom and banks are rocky. No data are available on
demolition holes in piers or abutments. AA emplacements or

other field fortifications do not exist at or near the bridge. The bridge can carry N type freight trains which have an axle pressure of 25 tons.
